SAMPLE DESCRIPTION:  
SPC flooring – Deko Extreme range flooring planks assembly.

## RESILIENT FLOOR COVERINGS (BASED ON ISO 4760:2022(E) - LAMINATE FLOORING – TOPICAL MOISTURE RESISTANCE – ASSEMBLED JOINT (MODIFIED))

**No. 1533837.9**

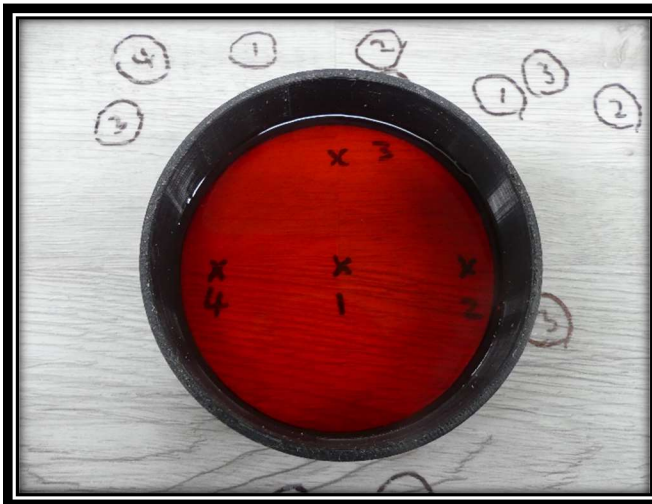
After 24 hrs With Water

100 mls of dye solution was applied onto the sample surface. It was poured into a cylinder 100mm diameter placed in the centre of the sample at the "T joint." Sealant was used at the plank/cylinder interface to avoid leakage.

The sample was placed on white paper towels prior to testing to enable detection of any dye penetration through the joints.

The sample was left at 20°C, 65% Relative Humidity room conditions for 24 hours after the dye was added and then examined for dye penetration through the backing (not 23°C, 50% RH as stated in the method).

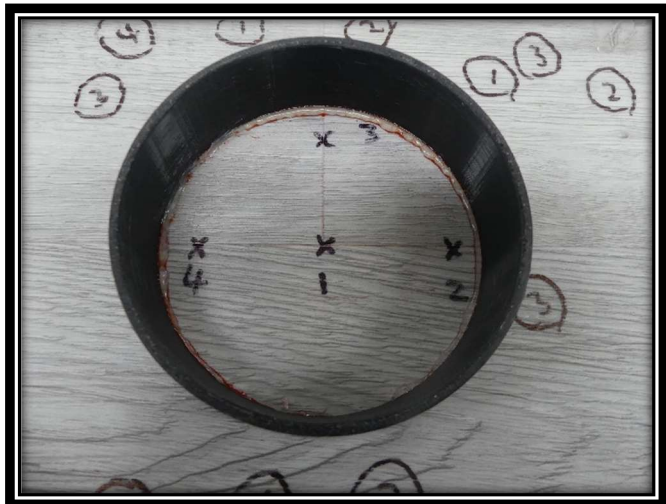
Wet Swell

Quantitative measurements are used to calculate surface swell in mm (within 15 minutes after water removal) and recovery swell (24 hours after removal of water).

Quantitative Results:	Wet Swell (mm)			Recovered Swell (mm)		
	Specimen 1	Specimen 2	Specimen 3	Specimen 1	Specimen 2	Specimen 3
Final Average Results (Positions 2 to 4)	0.02	0.01	0.02	0.03	0.04	0.01
Final Results (Position 1)	0.01	0.00	0.00	0.01	0.00	0.00

Wet Swell			Recovered Swell		
	Specimen 1	Specimen 2	Specimen 3	Specimen 1	Specimen 2	Specimen 3
Qualitative Ratings (individual results):	1	1	1	1	1	1

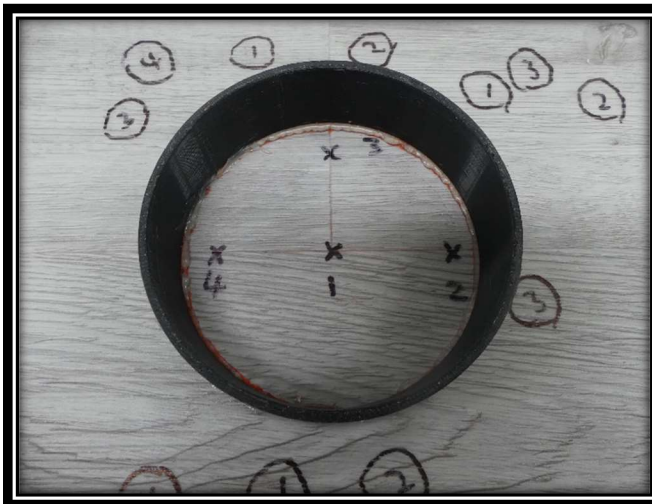
Recovered Swell

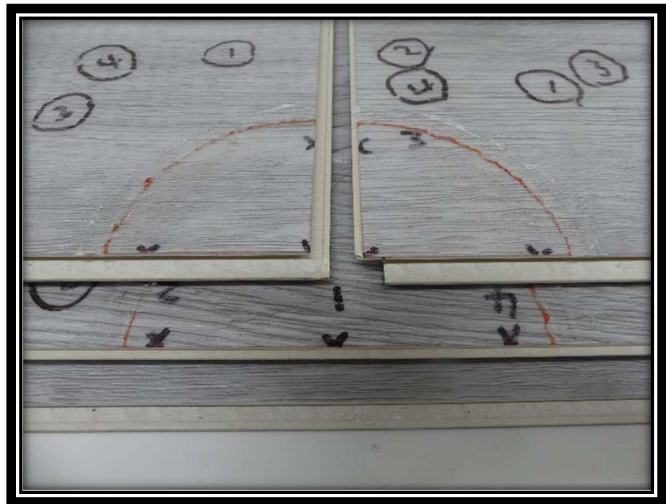
Recovered Swell (Disassembled)

Disassembly Observations:	Specimen 1	Specimen 2	Specimen 3
Migration of water along the upper surface:	No	No	No
Migration of water to the underside:	No	No	No
