SAMPLE DESCRIPTION:
SPC flooring – Deko Natural range flooring planks assembly.

RESILIENT FLOOR COVERINGS (BASED ON ISO 4760:2022(E) - LAMINATE FLOORING – TOPICAL MOISTURE RESISTANCE – ASSEMBLED JOINT (MODIFIED))

No. 1533836.1

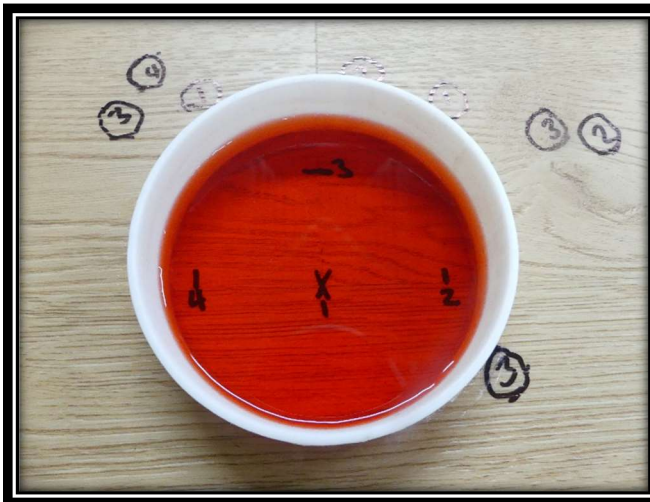
After 24 hrs With Water

100 mls of dye solution was applied onto the sample surface. It was poured into a cylinder 100mm diameter placed in the centre of the sample at the "T joint." Sealant was used at the plank/cylinder interface to avoid leakage.

The sample was placed on white paper towels prior to testing to enable detection of any dye penetration through the joints.

Observations:	Specimen 1	Specimen 2	Specimen 3
Migration of water along the upper surface:	No	No	No
Migration of water to the underside:	No	No	No

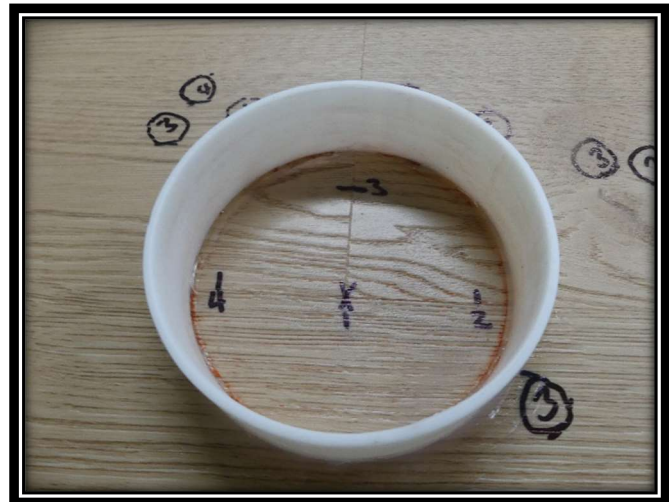
Wet Swell

Quantitative Results:	Wet Swell (mm)			Recovered Swell (mm)		
	Specimen 1	Specimen 2	Specimen 3	Specimen 1	Specimen 2	Specimen 3
Final Average Results (Positions 2 to 4)	0.00	0.01	0.00	0.00	0.00	0.00
Final Results (Position 1)	0.00	0.01	0.00	0.00	0.00	0.00

Wet Swell			Recovered Swell		
	Specimen 1	Specimen 2	Specimen 3	Specimen 1	Specimen 2	Specimen 3
Qualitative Ratings (individual results):	1	1	1	1	1	1

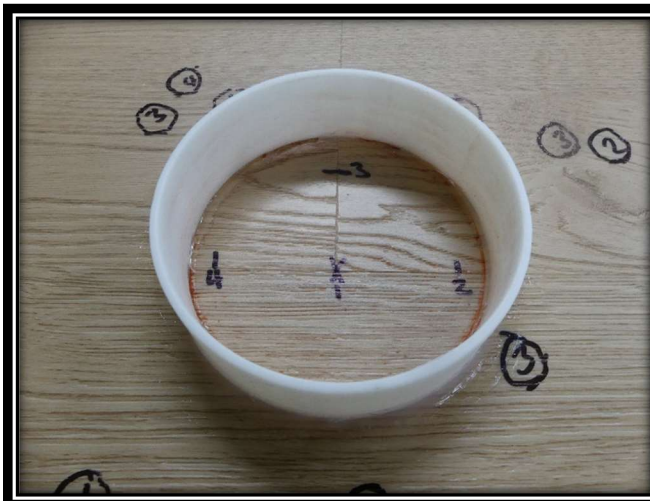
Recovered Swell
