SAMPLE DESCRIPTION:  
SPC flooring – Deko Stylex range flooring planks assembly.

## RESILIENT FLOOR COVERINGS (BASED ON ISO 4760:2022(E) - LAMINATE FLOORING – TOPICAL MOISTURE RESISTANCE – ASSEMBLED JOINT (MODIFIED))

**No. 1533838.7**

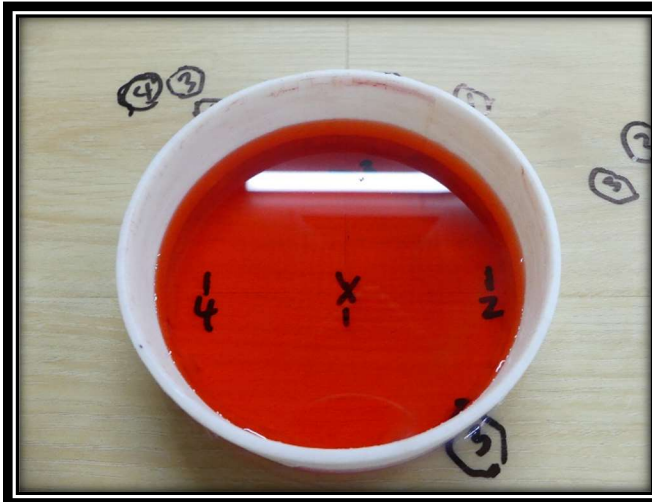
After 24 hrs With Water

100 mls of dye solution was applied onto the sample surface. It was poured into a cylinder 100mm diameter placed in the centre of the sample at the "T joint." Sealant was used at the plank/cylinder interface to avoid leakage.

Observations:	Specimen 1	Specimen 2	Specimen 3
Migration of water along the upper surface:	No	No	No
Migration of water to the underside:	No	No	No
